## AEC Industry Report

April 2018,  
Sponsored by ClearEdge3D

# OH, CRAP! 10 OF THE WORST CONSTRUCTION BLUNDERS AND HOW YOU CAN AVOID THEM

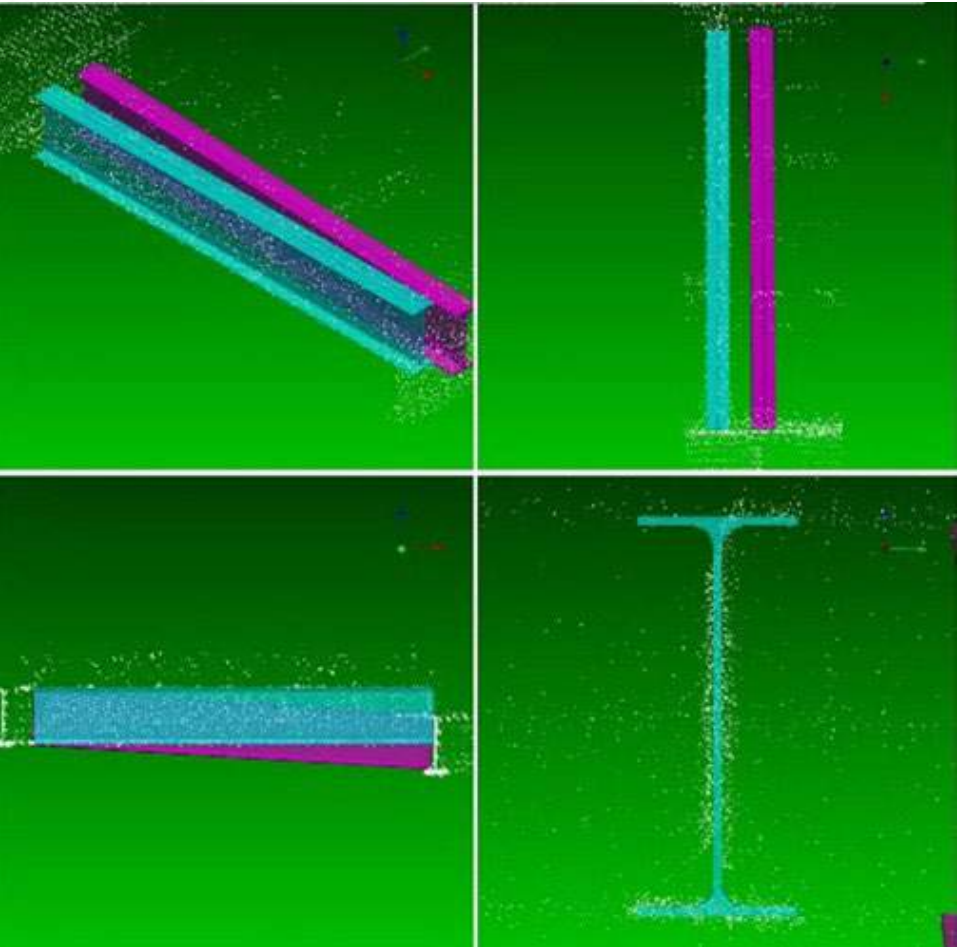
Item 16: Out of Tolerance  
W-Wide Flange || Structural Framing: W-Wide Flange: W10x12

While they found a few things to fix on the perimeter, what they found inside the building was the real surprise. The design model showed where there should have been sloped steel, but the scan showed that particular member as being installed perfectly flat. Additionally,

Taking a few steps back and looking at the project's design drawings, the cause of the confusion was easy to spot. The project's architect had annotated a slope on the architectural drawings that was missed by the structural engineer. While subcontractors are supposed to look at all the drawings, it is not uncommon for them to only refer to the structural drawings. Since the slope wasn't noted there, the subcontractor missed it and fabricated and installed the element flat.

This element should be sloping, it was installed horizontal!

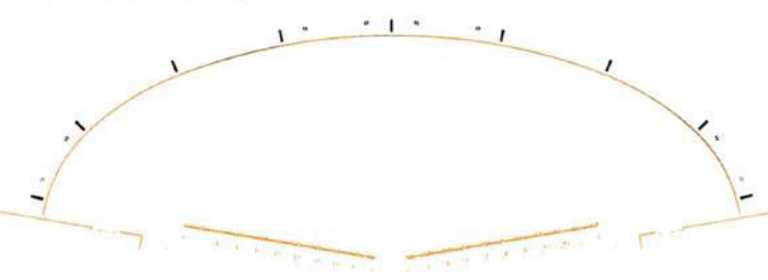
It was then determined that the fabric for the screen was stretching downward due to its own weight. The concrete was poured perfectly but it lacked sufficient bracing to support the weight of the massive screen. Laser scanning allowed for this "Aha!" moment and saved what could have been close to \$500,000 of unnecessary rework. The facility opened on time!

Plan View: SCREEN "A" TOP EDGE  
Major deviations can be seen on the top edge of the screen.

Plan View: SCREEN "A" BOTTOM EDGE  
Large deviations can be seen on the bottom edge.

Plan View: SCREEN "A" MIDDLE  
The middle of the screen has accurate alignment.

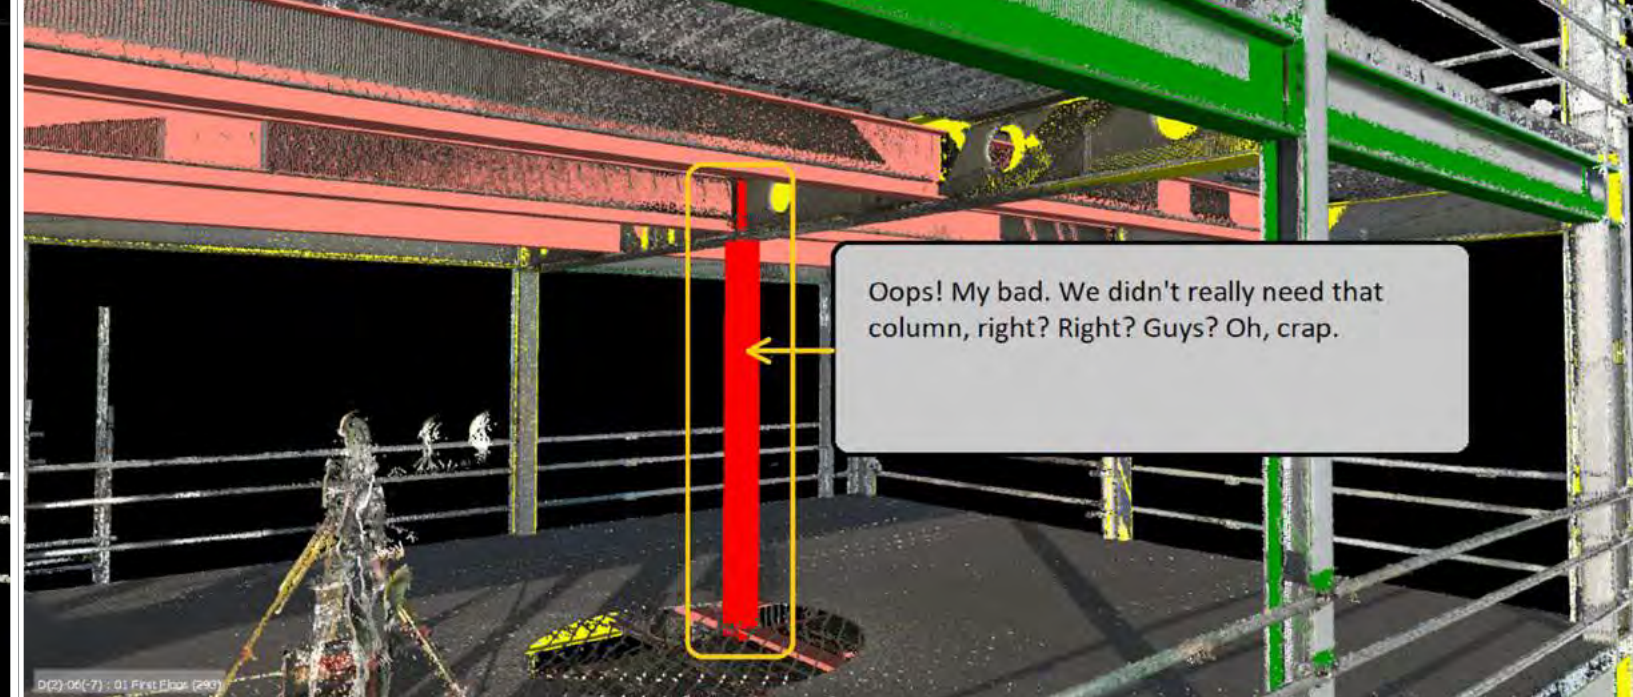
However, the laser scans performed by the customer of this project exposed something a bit different, something shocking. On the level where there was supposed to be a column, none was present. And on the level where the column was supposed to be absent, one had been installed! What happened? Did they change the design and decide to put the piece of equipment on a different floor? Had they failed to update the models? It was such a big mistake it was hard to believe it was real.

Oops! My bad. We didn't really need that column, right? Right? Guys? Oh, crap.
