# UPDATE OF LA CRESTA POA PAVEMENT MANAGEMENT PROGRAM

***FINAL REPORT***

***PAVEMENT MANAGEMENT PROGRAM***

***November 18, 2025***

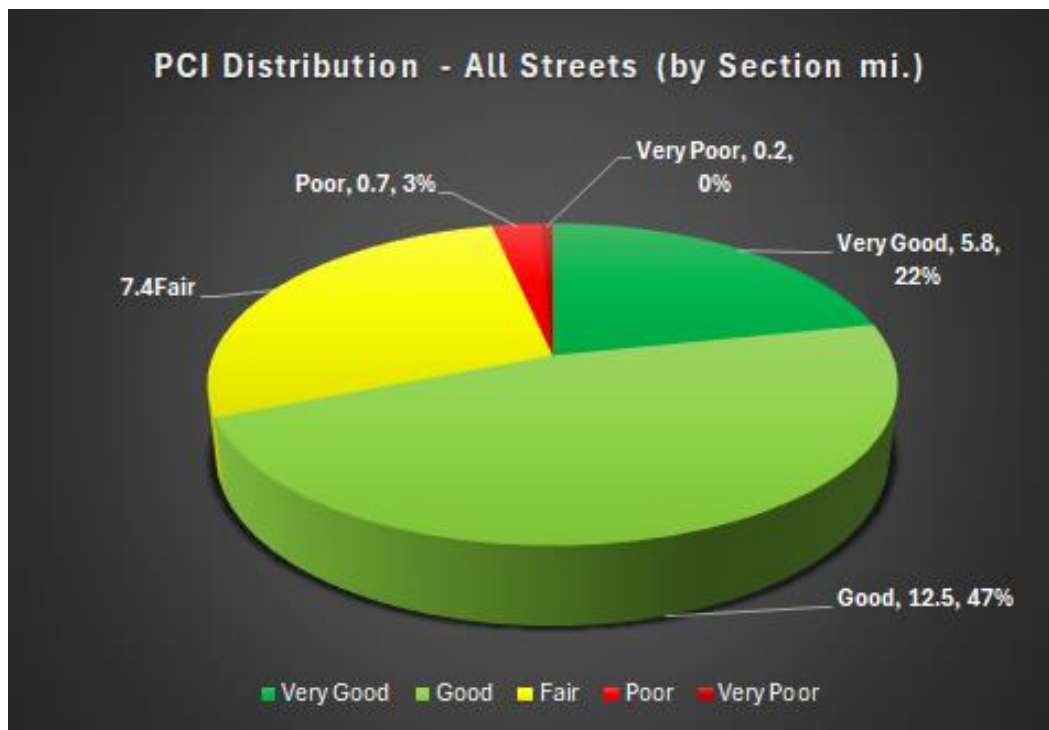
**Figure 2 – PCI Condition Distribution by Section Miles for All Streets**

As shown in Figure 2, 69% of La Cresta’s streets are in Very Good to Good condition. These sections will be targeted for “preventive” maintenance within our Capital Improvement Program (CIP) recommendations. The reasoning in doing this is to extend the life cycles of those “fair to good” pavement sections which accrues capital saving to aggressively rehabilitate those pavement sections that are below the “minimal level of service”.
