STRUCTURAL INTEGRITY RESERVE STUDY

**Pine Ridge North Village IV
Condominium Association, Inc.**

**800 Sky Pine Way
Greenacres, Florida 33415**

Project Number: 2409329

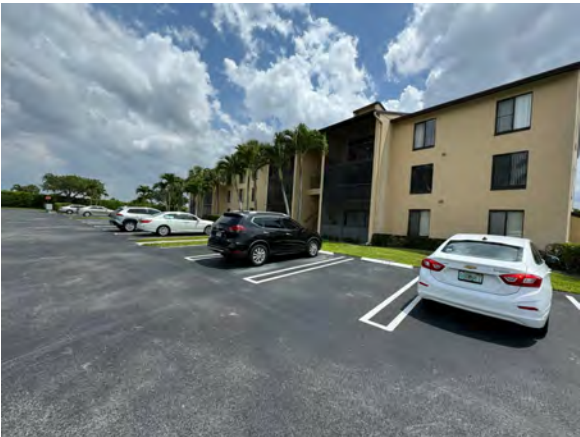
PHOTO 1

GENERAL VIEW OF PROPERTY

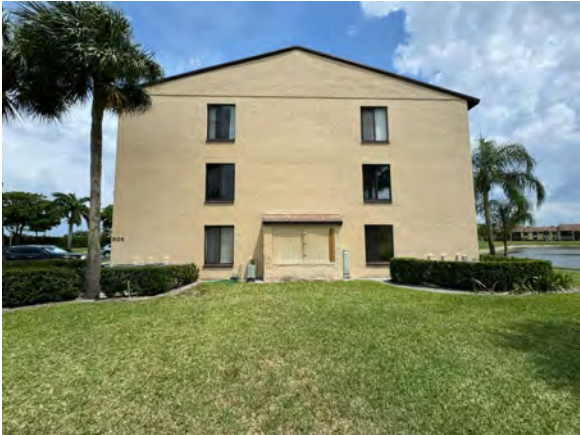
PHOTO 2

GENERAL VIEW OF PROPERTY

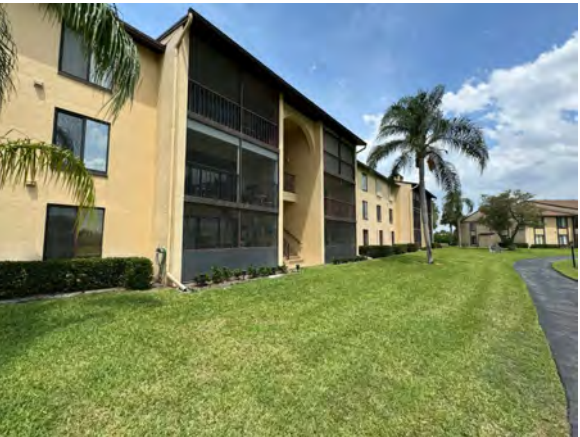
PHOTO 3

GENERAL VIEW OF PROPERTY

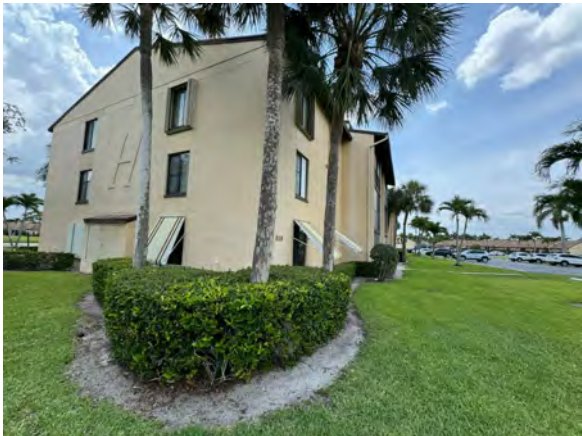
PHOTO 4

GENERAL VIEW OF PROPERTY

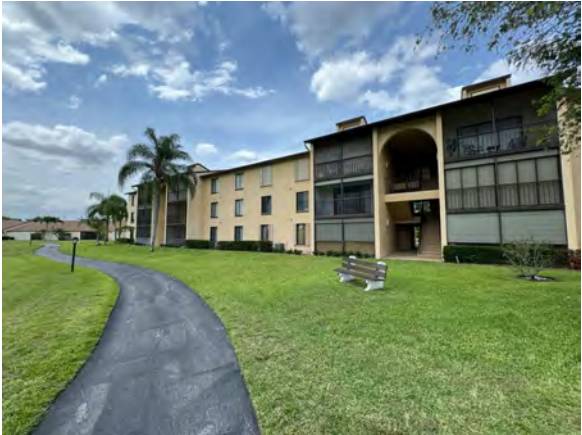
PHOTO 5

GENERAL VIEW OF PROPERTY

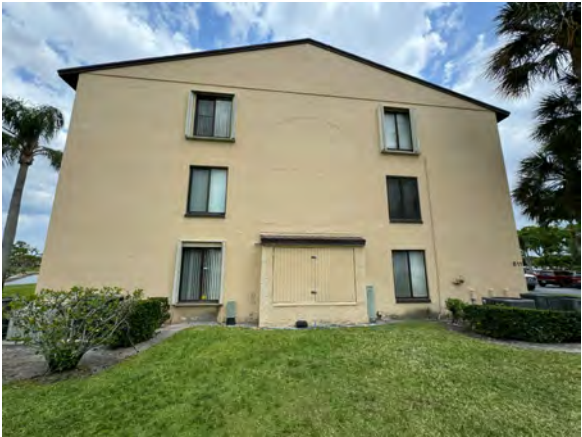
PHOTO 6

GENERAL VIEW OF PROPERTY

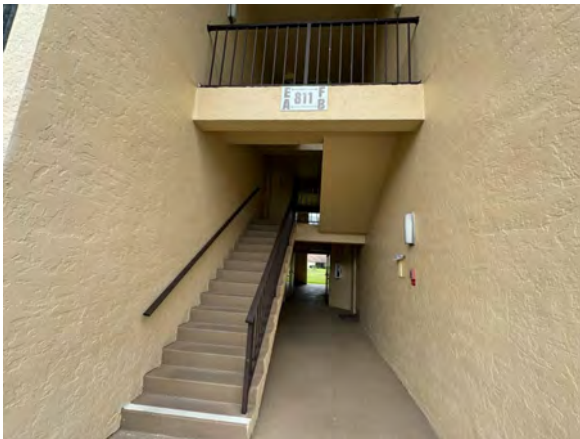
PHOTO 7

VIEW OF TYPICAL STAIR SYSTEM

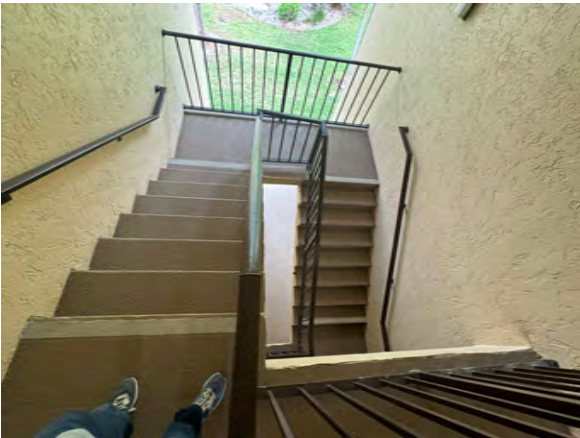
PHOTO 8

VIEW OF TYPICAL STAIR SYSTEM

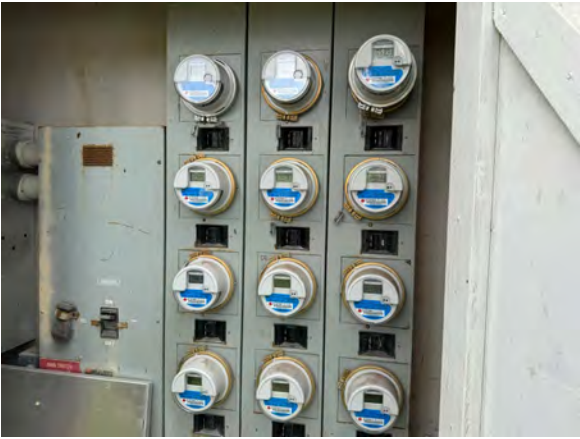
PHOTO 9

VIEW OF ELECATRICAL EQUIPMENT

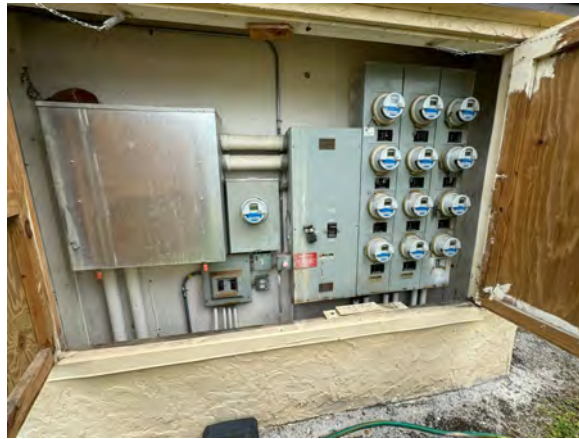
PHOTO 10

VIEW OF ELECTRICAL EQUIPMENT

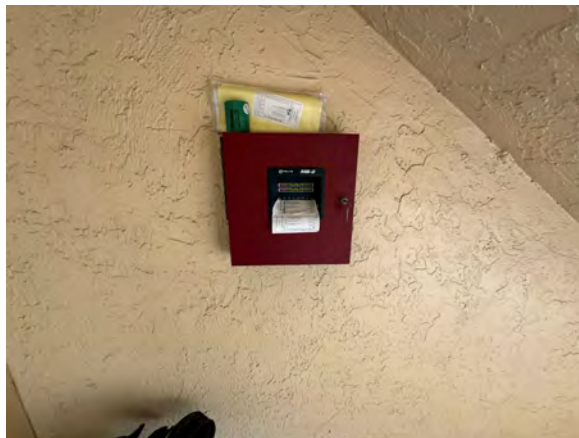
PHOTO 11

GENERAL VIEW OF TYPICAL FIRE ALARM CONTROL PANEL

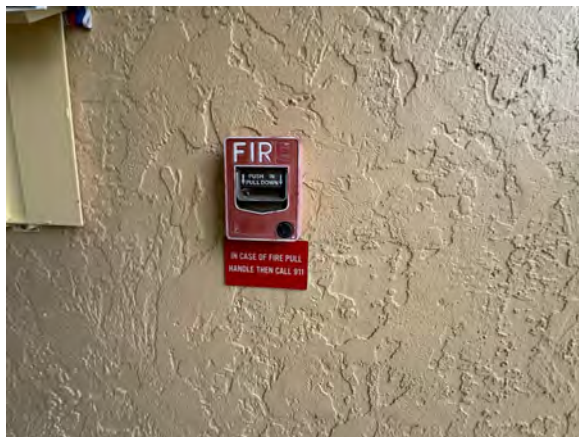
PHOTO 12

VIEW OF TYPICAL FIRE ALARM PULL STATION

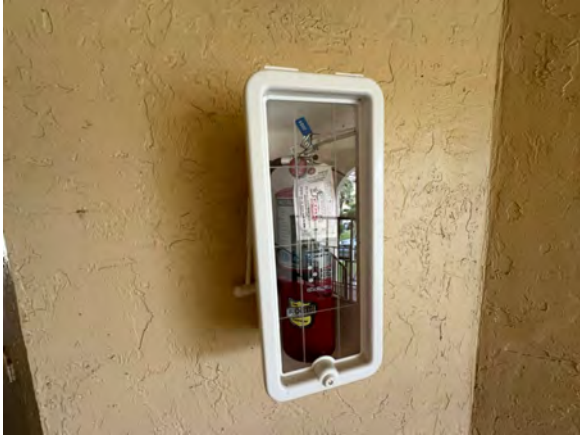
PHOTO 13

VIEW OF TYPICAL FIRE EXTINGUISHER

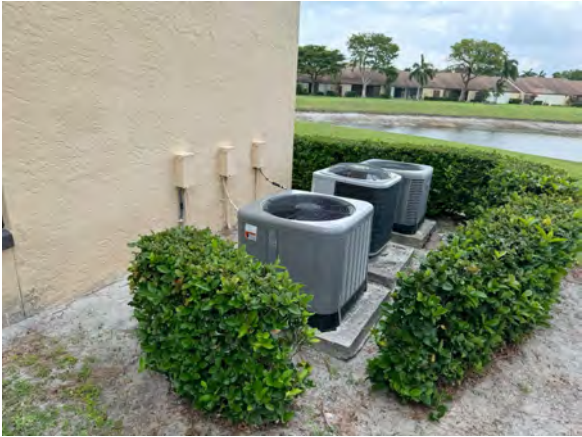
PHOTO 14

VIEW OF HVAC EQUIPMENT

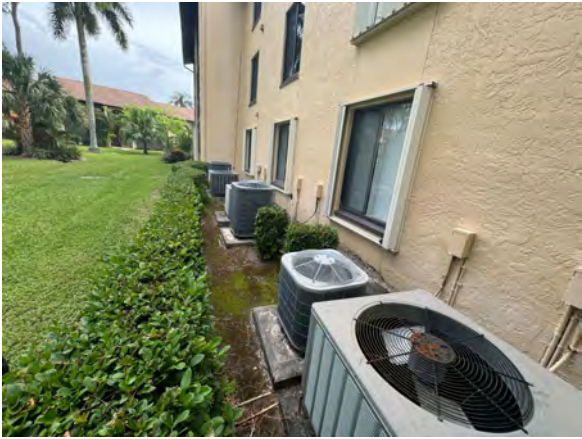
PHOTO 15

VIEW OF HVAC EQUIPMENT
