The Kenwood Collection: From Rust To Gold

Build Ohio Awards 2017
New Construction Over \$30 million

Excellence in Project Management

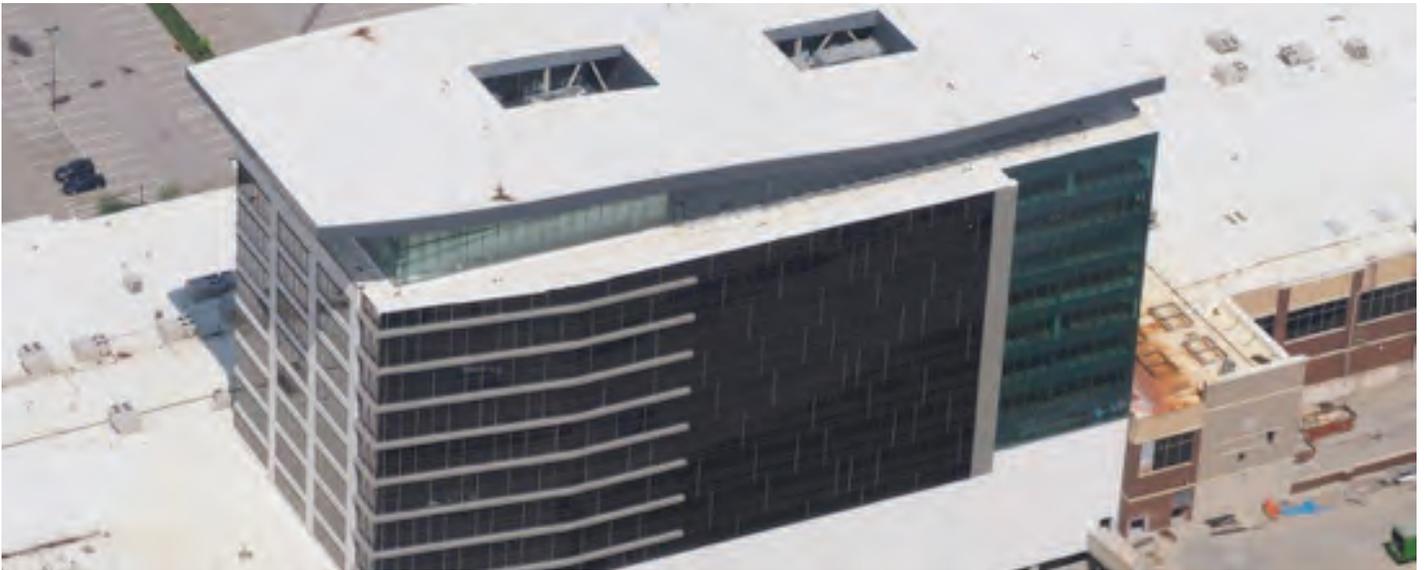
The Iconic Roof at The Kenwood Collection is one of the best examples of Messer's ability to influence modifications for exact fabrication and installation. Our team performed an as-built survey of the existing structural steel framing for the Iconic Roof to identify the future location of metal stud framing to which metal panels would be attached.

For this portion of scope, Messer field engineers utilized the reflectorless function of our Topcon robotic station to collect data (x,y, z) on the outermost edge of the perimeter. This scanning is a service Messer provides in-house to ensure quality, drive schedule, and control costs. The data acquired was exported into CAD and overlaid onto the metal panel shop drawings.

- The roof steel was designed on a compound radius (curves were both horizontal and vertical), portions of which extended beyond penthouse and building footprint. The radii were mirrored from the east to west elevations.
- Cold-formed metal stud framing and exterior board were fastened to perimeter steel framing. Insulated panels were installed to stud framing with 1" clips. Vertical panels were 59 1/2" wide, spaced 5/8" apart and had to align with horizontal soffit panels.

Field Engineering Services (FES) overlaid the design data onto the existing data and determined the extent of deviation. The findings were the proposed radii differed by several hundred feet, causing a shift in framing that would inhibit the designed 1" clip assembly. Based on these findings, the as-built drawing was used to change the design, ensuring it would mitigate the existing conditions.

The panel installer estimated 45 days for completion of this scope of work. **The Messer team's planning and execution ensured installation was completed 23 days early** with zero panels requiring modification in the field and zero panels needing to be reordered due to deficiencies.

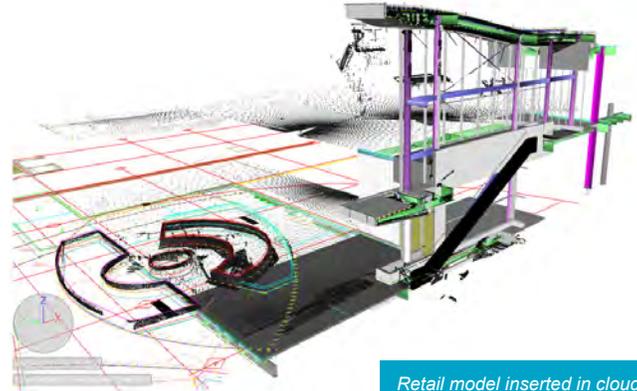
Retail model inserted in cloud

Laser Scan to BIM

In an effort to mitigate the risk involved with existing conditions analysis and the transition of the building, Messer advised the Owner, Phillips Edison and Architect, BHDP to consider 3D laser scanning and BIM utilization. By scanning over two-million square feet of office tower, retail, parking garage and site, a model based on real time point cloud enabled Messer to process an accurate Revit model of the existing space.

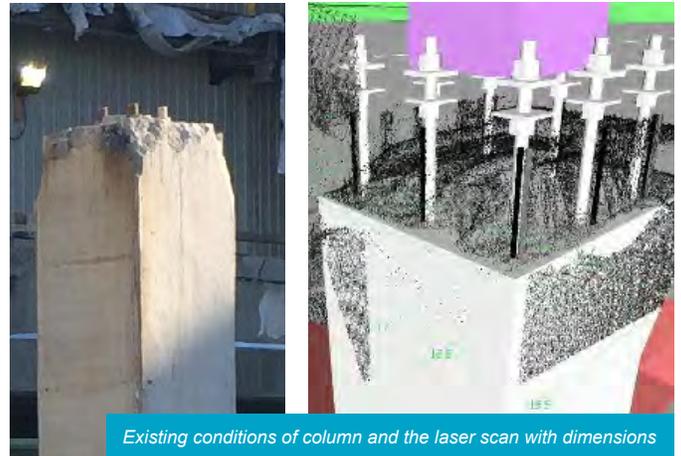
Existing conditions of column and the laser scan with dimensions

The scanning aspect allowed a safe way to measure inaccessible objects with millimeter accuracy; eighth-floor top of steel elevations for framing connections and fifteen floors of elevator analysis for eight shafts for measured with the scan. Through reliance on the model-based element, tape measuring and human error was reduced, as well as the administrative time associated with processing requests for information, submittal approval and change orders. For example, not one panel from the iconic roof had to be cut, because we guaranteed dimensional changes to the model, generated by our field verifications. The cost avoidance impact of our integrated scan-to-BIM work flow saved the project an estimated 5% of total contract amount.

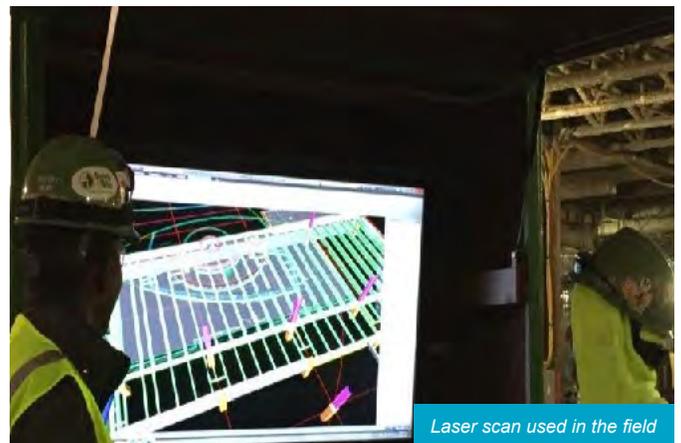
Laser scan used in the field
