## AEC Industry Report

April 2018,  
Sponsored by ClearEdge3D

# OH, CRAP! 10 OF THE WORST CONSTRUCTION BLUNDERS AND HOW YOU CAN AVOID THEM

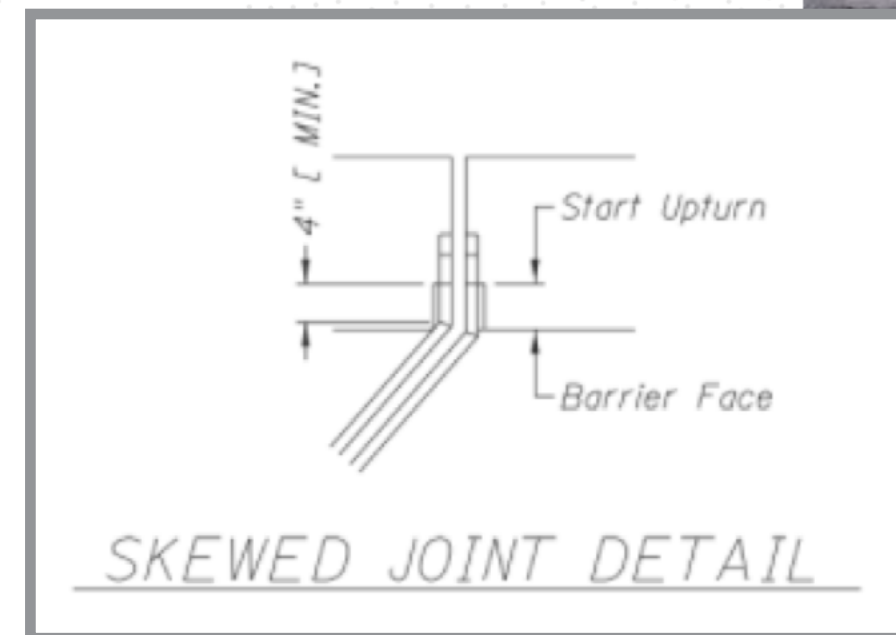
Insufficient design detail causes complete rework and expansion delay for a railway overpass project.

The build was later inspected and approved by the Department of Transportation as it appeared to conform to the limited information provided in the single detail drawings. It wasn't until the DOT came to view the finished project that the problems with the constructed detail became evident. They found multiple areas of concern and required the ends of the expansion joints be entirely redone. Each of the four joints had to be revised and the additional work cost upwards of \$30,000 in materials and delayed the project several weeks. This delay also impacted the opening of a major thoroughfare dependent on this project's completion.

The problems in this project could have easily been solved through a simple 3D model of the existing conditions and the proposed design—or by simply providing more 2D details upon request. This would have saved the contractor and the field team a lot of time and money from the start.

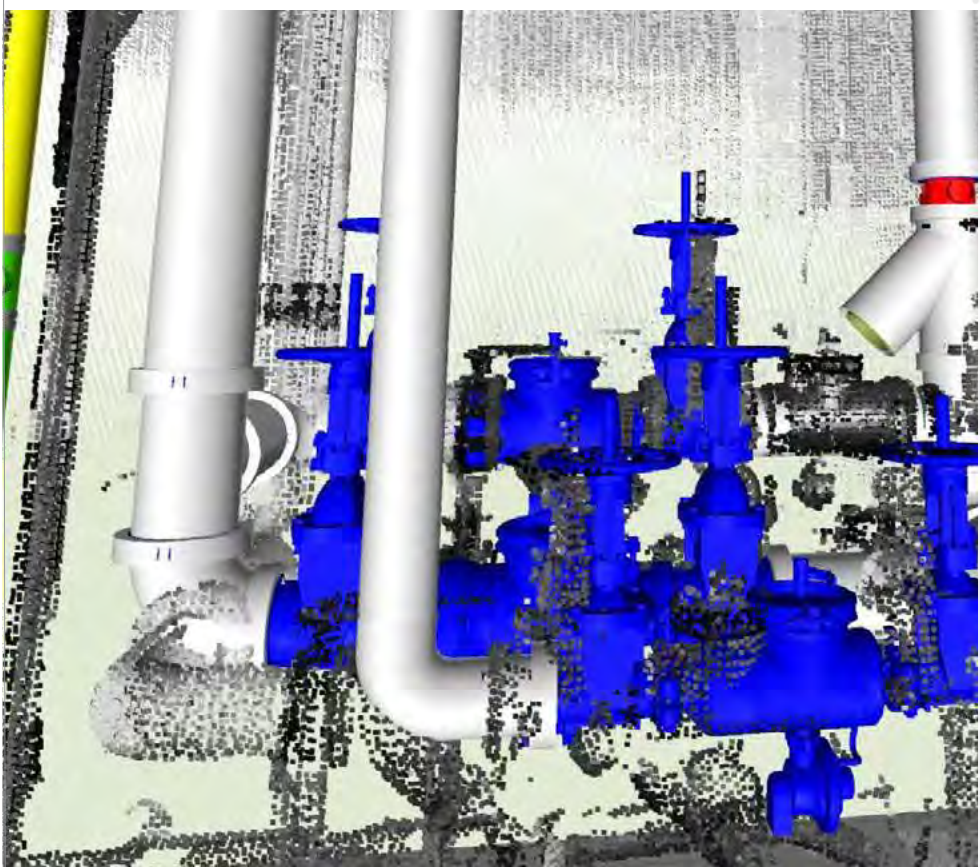
The project team had already noted some differences between the as-built drawings and the installed work but didn't know how much was incorrect because traditional spot-checking only validates a small percentage of the work. When it came time to perform the quality control checks on the installed work prior to handing the building over to the client, Cone's team chose to laser scan the CUP and use Verity construction verification software to perform the quality

*"The field crews did a great job of reducing the linear footage of piping required, but they never documented the changes into the as-builts. When we were brought in for the final QC checks before hand-over, we chose to laser scan the CUP and use Verity to perform the analysis. Within a few hours it was revealed that 80% of the piping was not installed per the final "as-built" drawings."*

Traditional quality control methods in the field only validate a tiny fraction of the work. Using a more rigorous process to check all the work catches the problems you didn't even know to look for. By following the BIM or properly documenting field changes, it would have prevented all the damage to the subcontractor's budget and possible reputation.

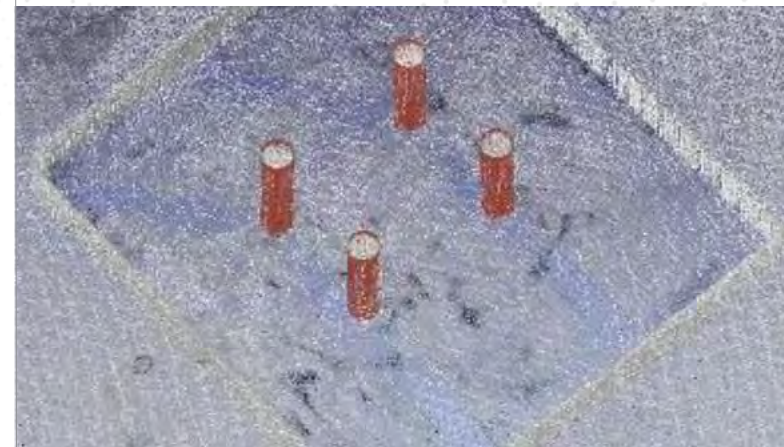
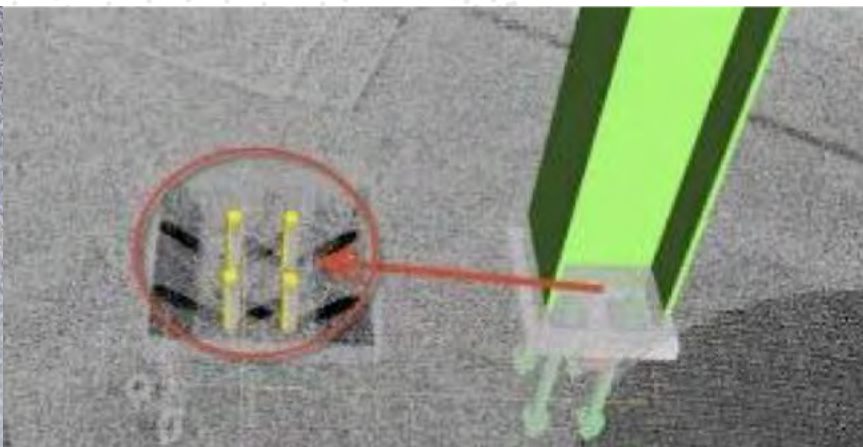
Anchor rod misalignment on over half of a structure's 40 columns causes project delay.

“We often see problems like these anchor rods being out of tolerance in projects where cross-trade coordination fails. By using BIM and a robotic total station layout before the pour, you’re creating a workflow that will invariably reduce these kinds of errors and ultimately keep costs down and the project on schedule.” — Will Ikerd, P.E., Principal, IKERD

Structural steel erection is so fundamental to the construction process that a project cannot move forward until it's completed—and completed correctly. Had the GC's workflow included identifying critical areas for scanning at key intervals, the anchor rods would have been corrected before the concrete was poured eliminating significant delays, rework, and money.

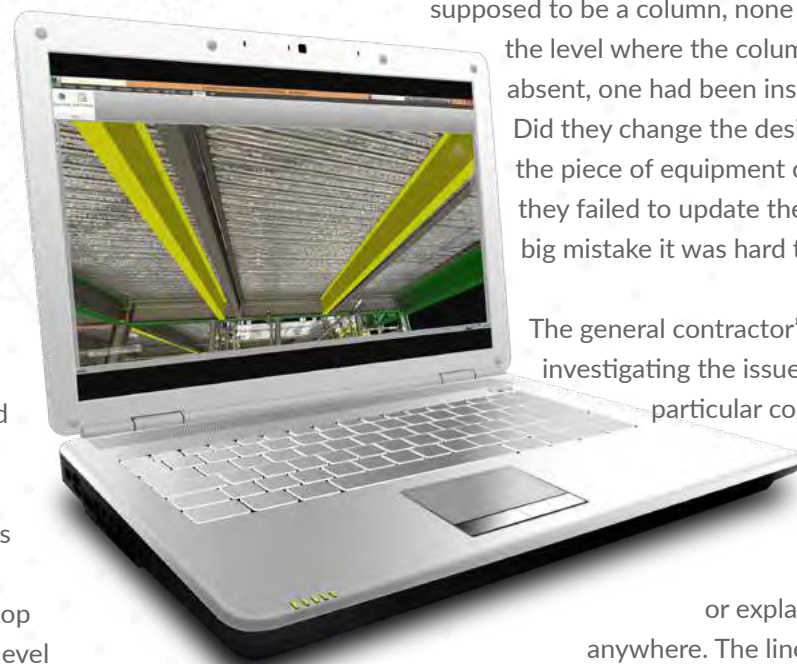
However, the laser scans performed by the customer of this project exposed something a bit different, something shocking. On the level where there was supposed to be a column, none was present. And on the level where the column was supposed to be absent, one had been installed! What happened? Did they change the design and decide to put the piece of equipment on a different floor? Had they failed to update the models? It was such a big mistake it was hard to believe it was real.

The general contractor's project team started investigating the issue. As it turns out, this particular column situation was obvious in the 3D model, but the drawings did not have clear notation or explanation of the condition anywhere. The lines on paper were correct, but it took a lot of digging through the drawings to figure out what was intended from the 2D documents. The steel subcontractor hadn't figured it out, and the end result was exactly what it looked like in the Verity

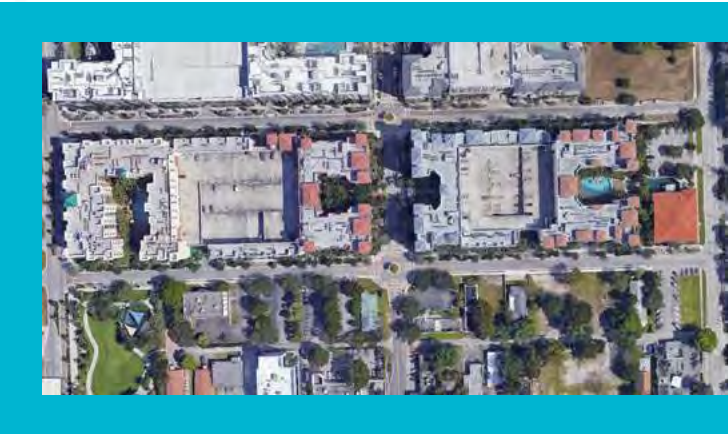
Preceding the adoption and use of BIM, the same general contractor used a civil engineer that made a mistake placing the building properly on the site. This caused cascading problems with just about everything you can imagine – changes to the plans and the building footprint, associated redesign costs, conflicts with the neighboring businesses, and litigation. This put the project into a year-long standstill (in addition to a hurricane damaging the partially built structure). The general contractor cost the parties involved tens of millions of dollars and lost hope of any future work from that client. The project did eventually get finished, but the blunder left a lasting impression on all those
