**RETHINKING
DUCTWORK**

Luther Home of Mercy: Case Study

THE IMPACT OF DIFFERING HVAC DUCTWORK SPECIFICATIONS
ON AIR LEAKAGE, ENERGY USAGE, CO₂ EMISSIONS & COSTS

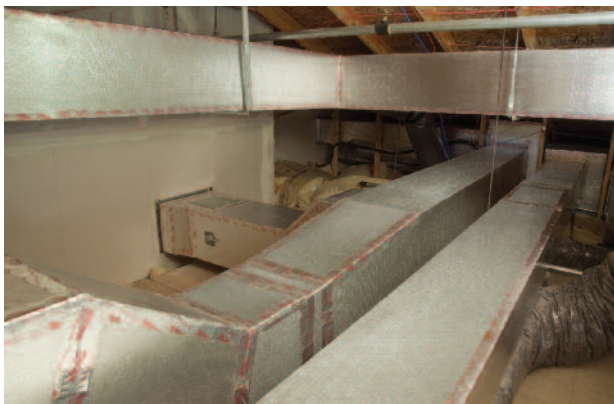
Figure 4: Cottage 6A, *Kingspan KoolDuct*[®] System Ductwork Installation

The recorded air leakage of the ductwork fabricated from the *Kingspan KoolDuct® System*, at the specified static pressure of 2 in.w.g, was 469 CFM. This represents 6.7% of the operating supply total air volume (6985 CFM). The recorded air leakage of the glass fiber insulated sheet metal ductwork was 2306 CFM, representing 33% of the total air volume.

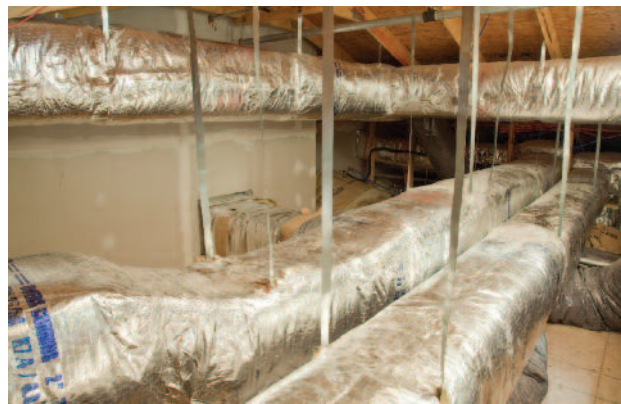
Figure 5: Cottage 6B, Glass Fiber Insulated Sheet Metal Ductwork Installation

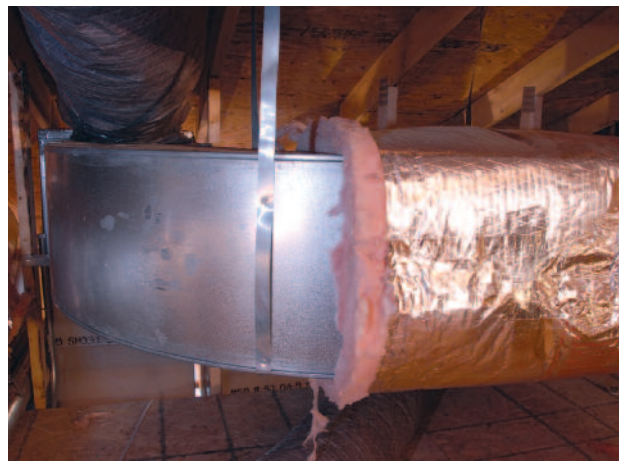
Figure 6: Sheet metal ductwork requires a separate manual wrapping operation

The lower capital cost results primarily from the lower labor cost associated with the *Kingspan KoolDuct*[®] System, largely a result of the increased speed with which it can be installed. This is a result of the fact that the *Kingspan KoolDuct*[®] System is a single fix installation, and eliminates the separate manual process of wrapping the insulation around the ductwork.
