Hot Heads 2; Advanced Cooling System Design and Diagnosis

Instructor: Donny Seyfer AAM

HOT HEADS 2; Cooling System Design and Diagnosis

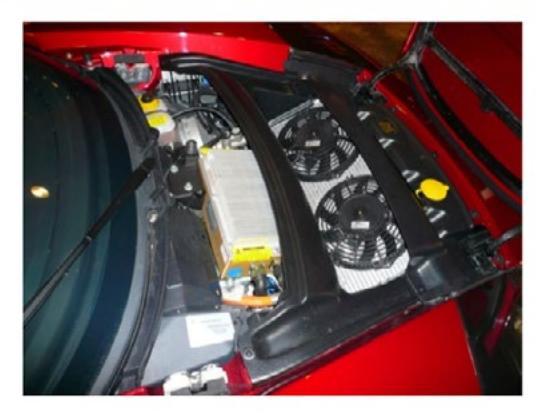
Tesla battery cooling system

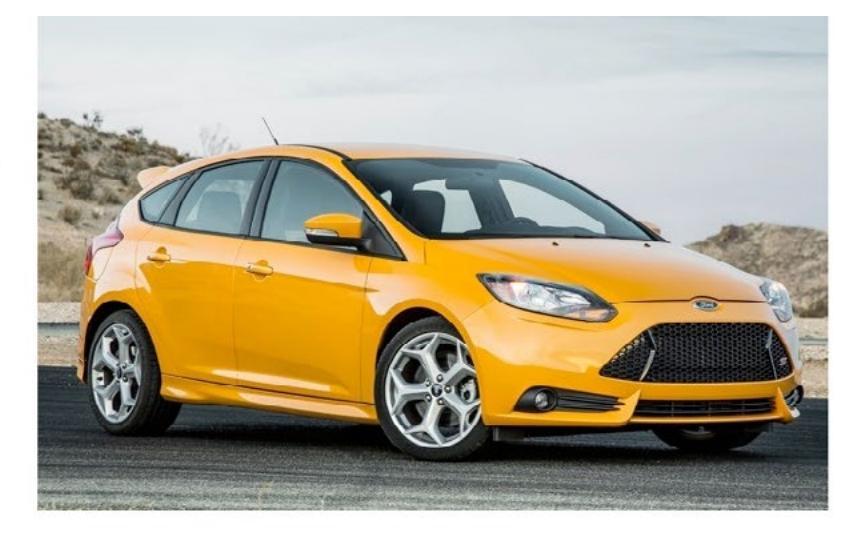
2013 Focus ST 265 Horsepower 285 lb/ft Torque 2.0L Ecoboost I-4

\swarrow Fully warmed up within 1 minute 30 seconds on a 40 degree

day.

```
Coolant capacity - 6.4 quarts
```

☆BTU generated by engine - about 33715/min at WOT

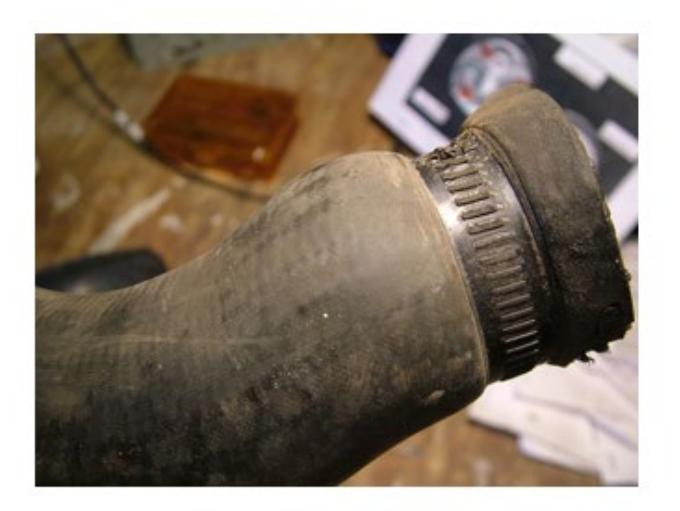
Radiator hoses don't do this much anymore

- Most Radiator Hoses are made of EPDM and will last 7-10 years.
- Hoses can get hard and damage radiators and plastic attaching parts because they do not flex as designed anymore.
- Most OE's have gone to spring clamp or heat shring hose clamps to maintain even pressure and reduce cold leaks.
- Hoses absorb the additive packs in antifreeze.
- Anytime a hose is replaced the antifreeze should be replaces as well to ensure adequate protection for other parts of the cooling system.

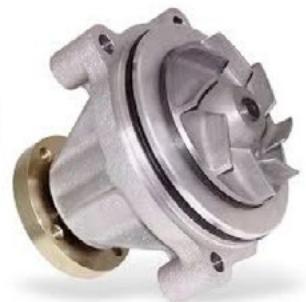
Replaced during timing belt replacement Water pumps are designed to last 150K Cooling system must be flushed and coolant replaced during replacement

When water pumps fail there is almost always something wrong in the cooling system. Mechanical failure rate on water pumps is only about 2%. Common symptoms:

- Debris in cooling system
- Exhausted add packs in coolant
- Restrictions in radiator
- Mixing of coolants
- Incorrect coolant mix

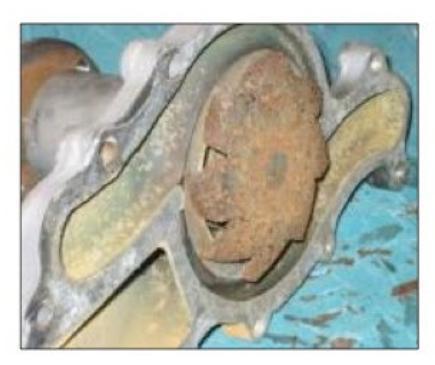
Debris in system

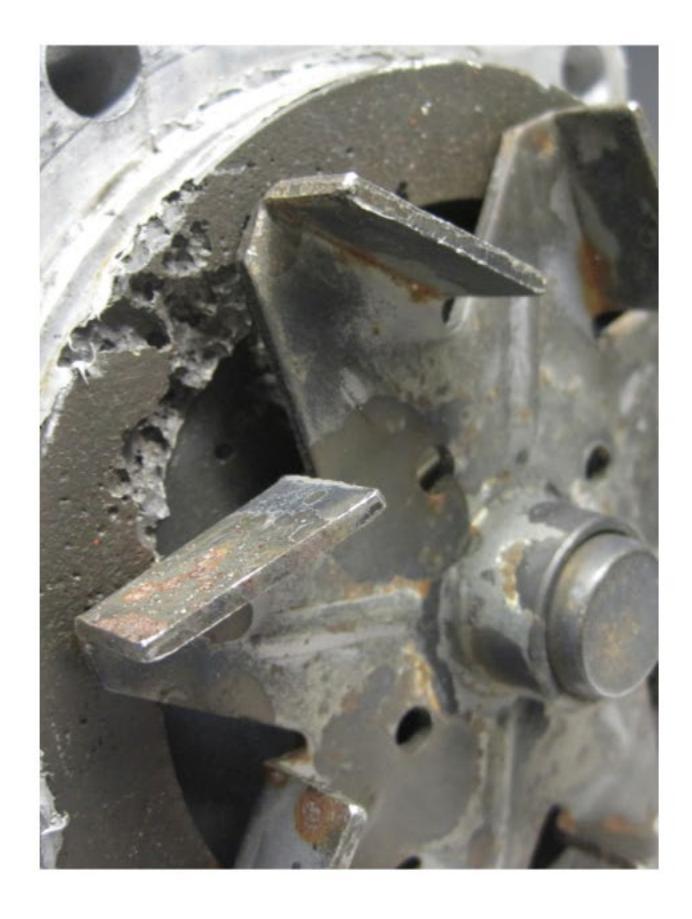
Cavitation

- Contrary to popular belief is not air bubbles
- Actually is vacuum bubbles
- Caused by a restriction in flow and coolant failure
- Results in the equivalent of a sonic boom.

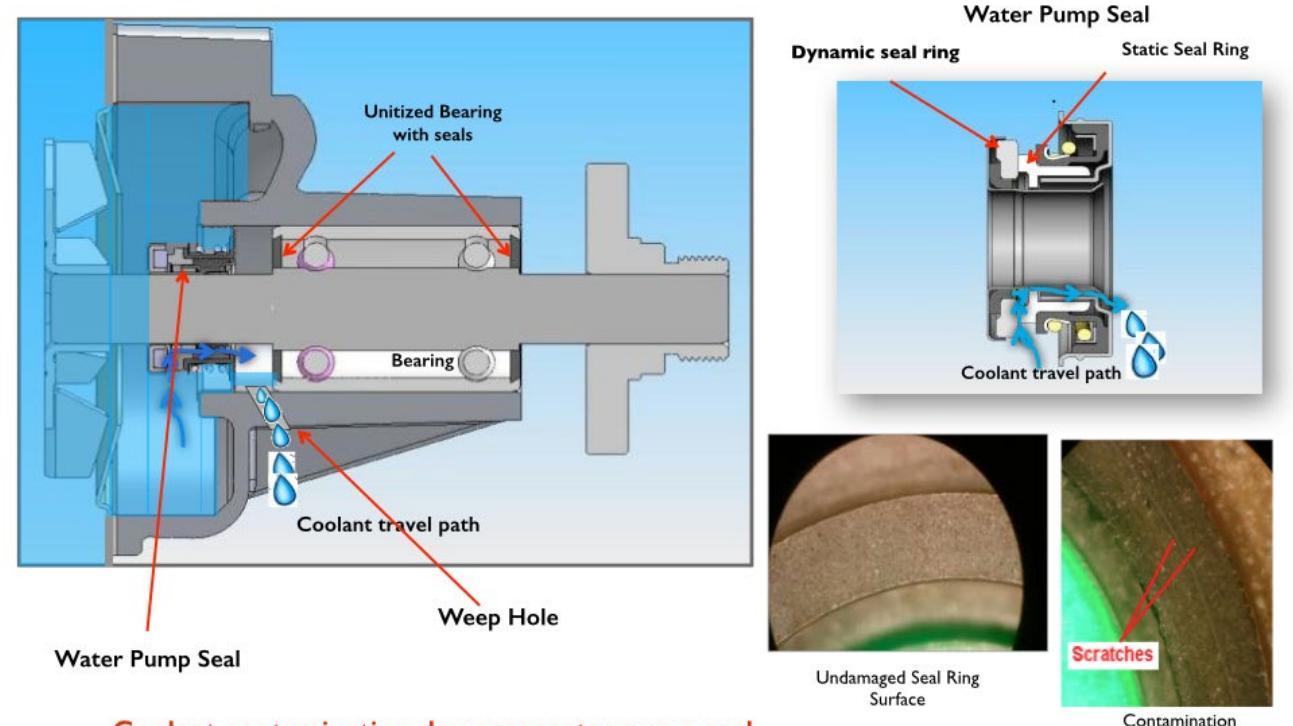
How weep hole leaks damage bearings

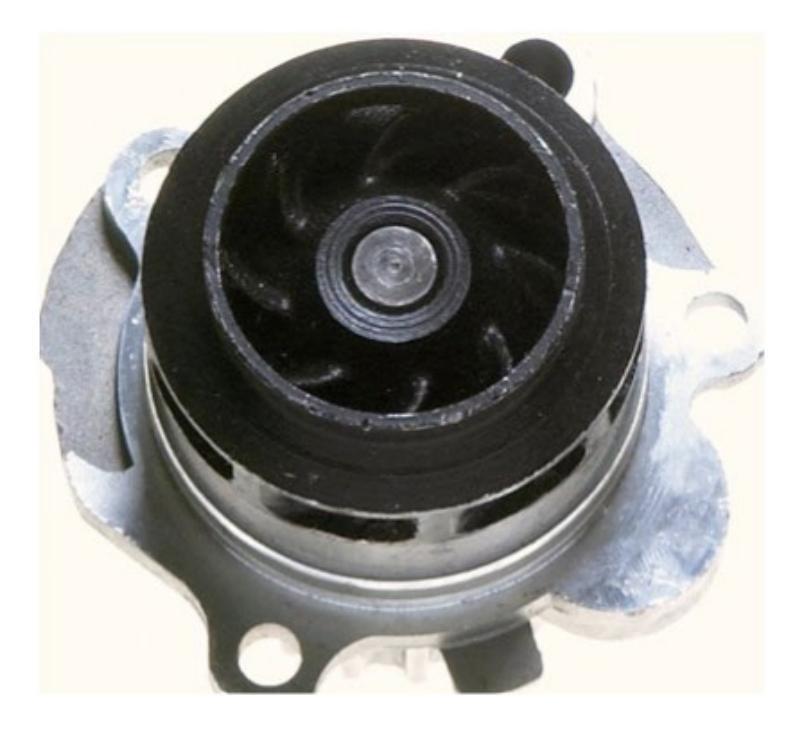
Coolant contamination damages water pump seal

- Slight leakage is a normal part of water pump lubrication in many designs.
- Major leaks are caused by scratched or grooved seal surfaces
- Seals are damaged by lack of lubrication from low coolant or exhausted add packs
- Seals are damaged by debris in system.

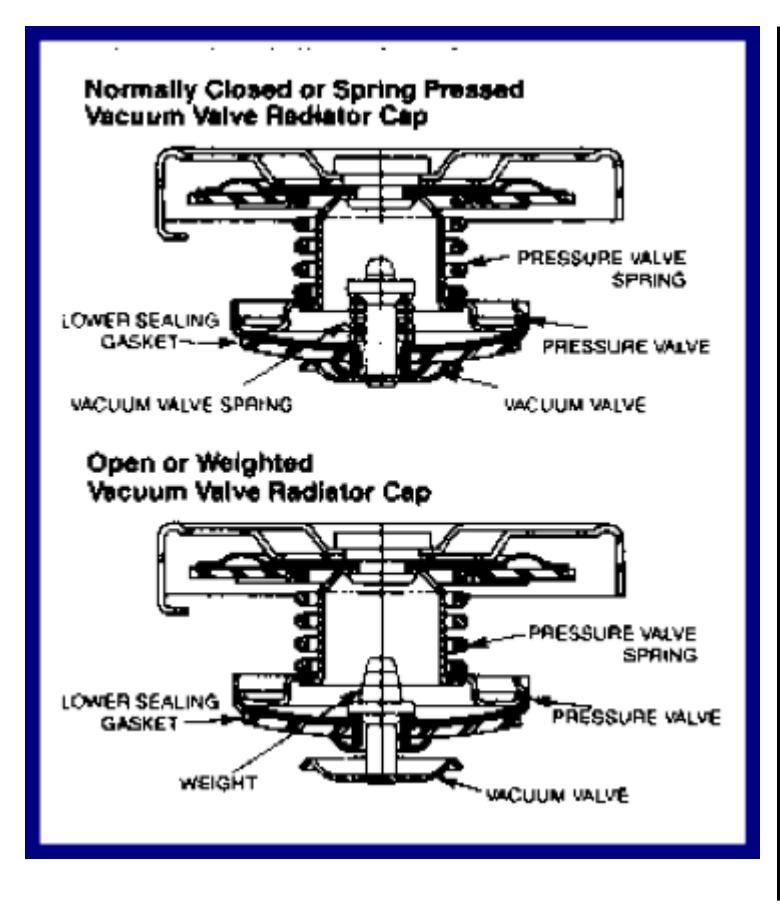
Radiator Caps

- The pressure valve uses spring pressure so the cooling system can maintain above ambient pressure.
- 50/50 coolant boils at about 227 f.
 under ambient pressure
- At 14psi it climbs to 263F.
- The pressure valve allows small amount of coolant to be pushed into the recovery to account for expansion.
- It is critical to keep air out of cooling systems
- When a system cools it contracts creating vacuum
- The vacuum valve normalizes system vacuum by drawing cooling back from the overflow reservoir.
- A failed vacuum valve will generally result in hoses sucked flat when the engine is cooled down.

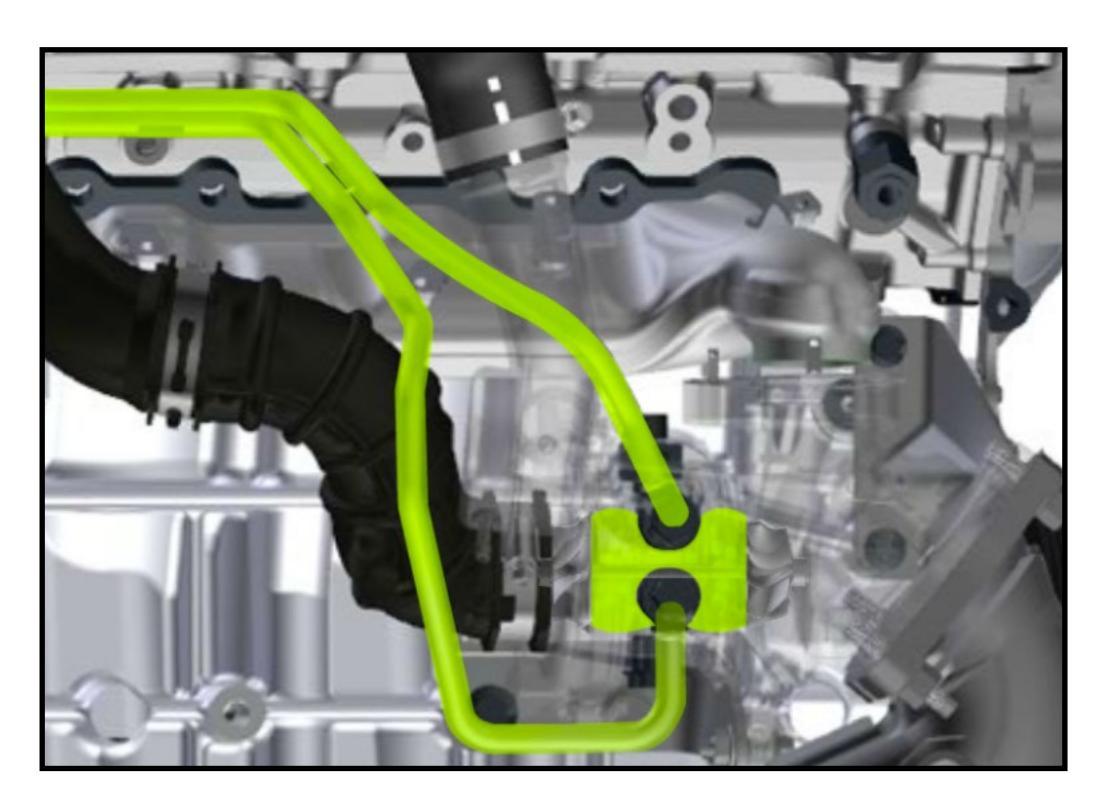
Thermo-Siphoning

Ford and others use a technique called thermo-siphoning to protect and cool Turbo-Charger bearing housings after shutdown. This is the Ford EcoBoost 2.0L.

The coolant uses convection and a loop. The hot coolant rises and as it cools it runs back down the loop. This will continue until the bearing housing reaches temperature parity with the coolant.

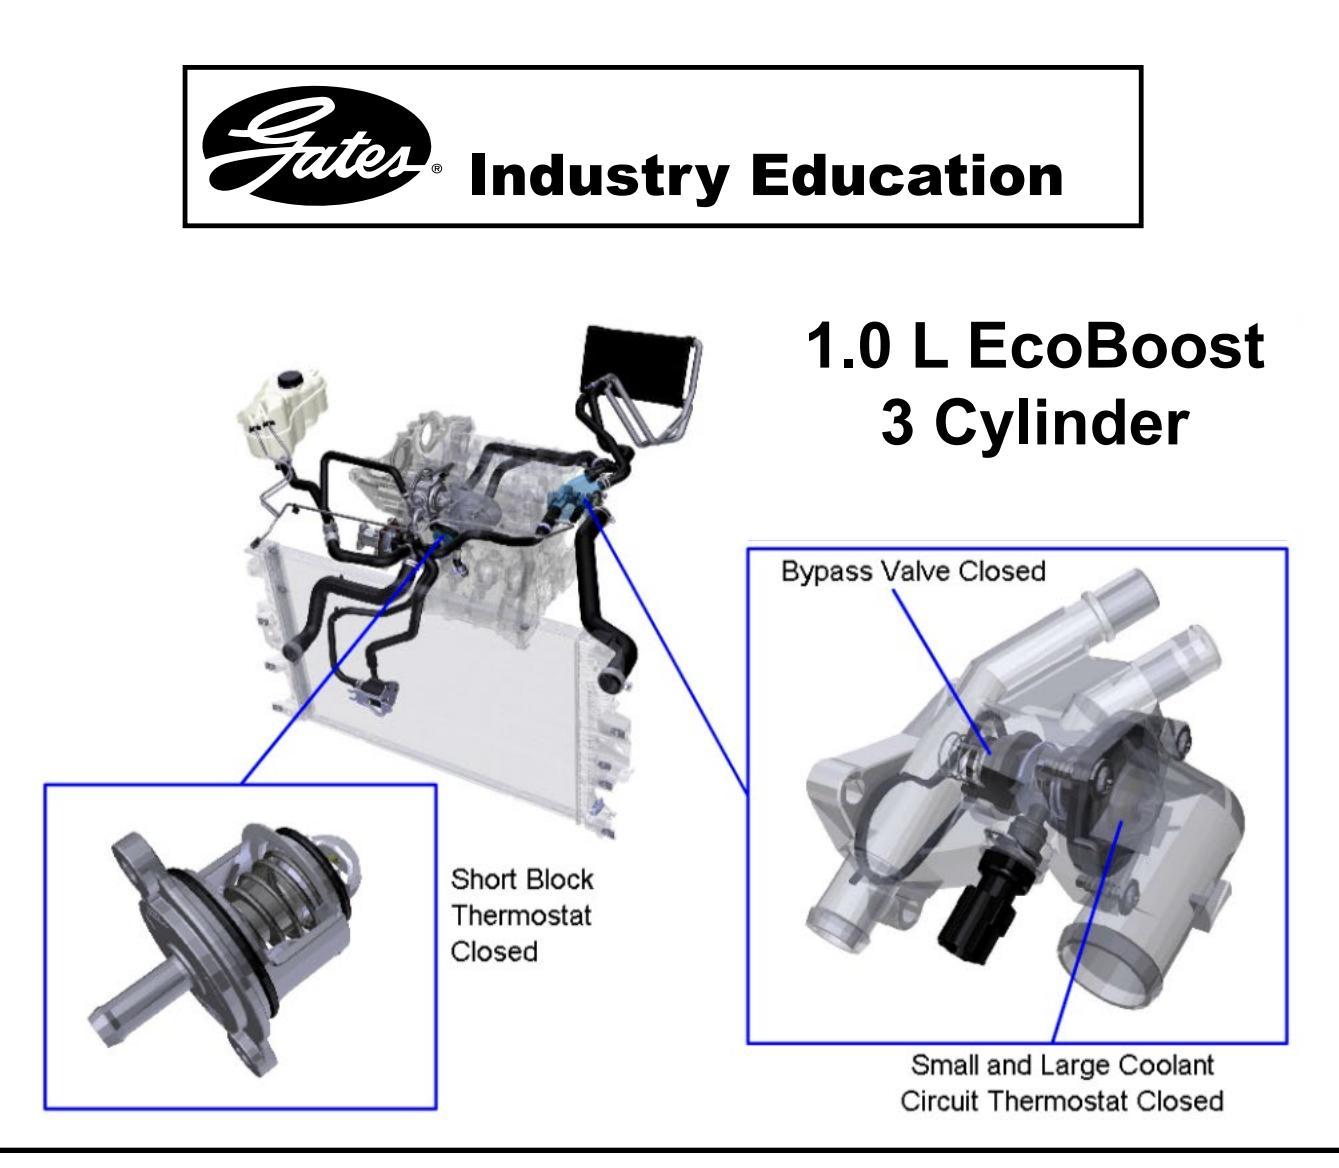
- Electric Turbo cool down pump (activated on shutdown after hard use)
- 3 different cooling circuits that are mechanically controlled
- The large and small cooling circuits operate like traditional open and closed thermostat systems
- The mini cooling system is focused on warm up and routes coolant to heater core, cylinder head exhaust side and oil cooler
- Keep in mind the exhaust manifold is built into the head so the mini cooling system helps to avoid hot spots in the head and distribute and recycle thermal energy

- System Pressure test 21.7 PSI all but 3.5L appear the same
- Coolant capacity 6.1 qts new formula Dexcool WSS-M97B44-D2
- Cylinder block Thermostat begins to open at 158 fully open at 185
- Other Thermostat begins to open at 197 fully open at 223
- Behind grille there is an active shutter system to control air through radiator core. (Fiesta, Focus and Escape)

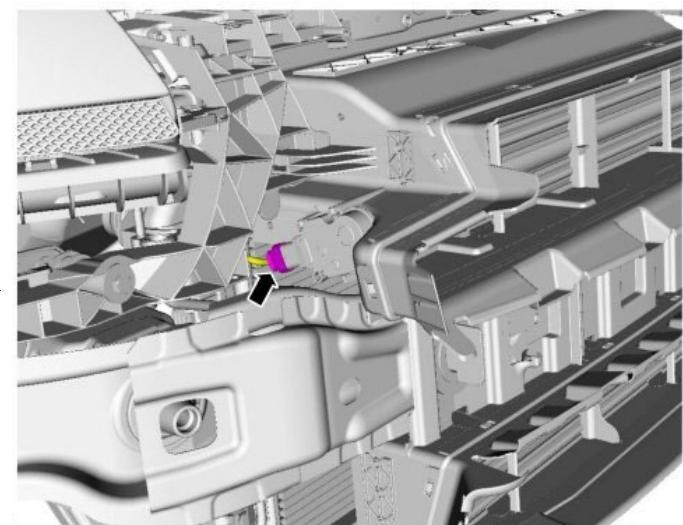
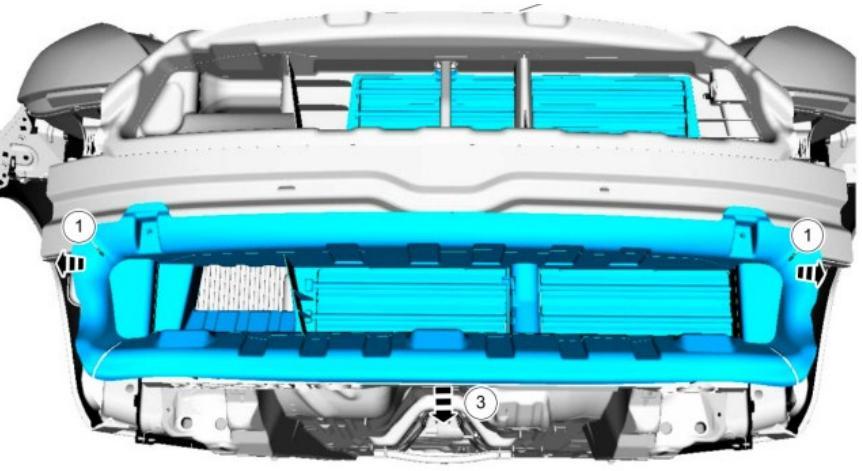
Ford Escape and Ford Fiesta

Active Grille Shutter

The grille shutter actuator positions the grille shutters based on commands from the PCM. The grille shutter moves 90 degrees from fully closed to fully open and, based on the position commanded by the PCM, is set in 1 of 16 positions (approximately 6 degrees between positions).

During normal operation, the grille shutter may be partially to fully open when the engine is off, depending on the ambient temperature. After an engine starting event,

a calibration of the grille shutter system occurs, which typically takes 15-20 seconds. The grille shutter system performs the calibration sequence by detecting the end positions, open and closed. The calibration sequence can begin in either direction, open or closed, and continues until it is successful or a fault is sensed. A long pause may occur between the 2 portions (open/ close) of the calibration sequence. If certain faults are present (shutter blocked or actuator error), a recalibration is initiated in an attempt to resolve the problem. If

the problem is not resolved after a calibrated number of attempts (usually 3 or 4), a timer starts and sets a DTC when the timer reaches a predetermined limit. Other faults also trigger a recalibration request, but not until a grille shutter DTC is set in the PCM.

The PCM communicates the desired position (open or closed) of the grille shutter based on various PCM inputs (vehicle speed, coolant temperature, ambient temperature, A/C system pressure, etc.). The PCM communicates to the grille shutter actuator via a LIN. The LIN supports bi-directional communication between the grille shutter actuator and PCM, allowing the grille shutter actuator to communicate position and fault information to the PCM.

The PCM sets grille shutter Diagnostic Trouble Codes (DTCs) when the fault information is communicated by the grille shutter actuator for a predetermined amount of time. Any failures of the LIN for over 10 seconds continuously results in the grille shutter actuator positioning the grille shutter fully open. There is no indication to the driver of the vehicle when a fault with the grille shutter system is present or a grille shutter DTC is set in the PCM.

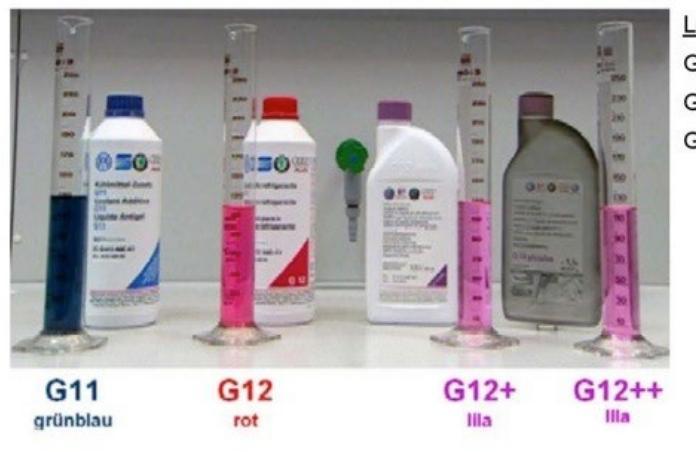
VW/Audi example

Legend: G11 - green-blue G12 - red G12+ and G12++ - purple

Note: The photo above is for color identification only, your packaging may vary.

G12+ aka Phosphate-free coolant G 012 A8F

G12++ aka Phosphate-free coolant G 012 A8G

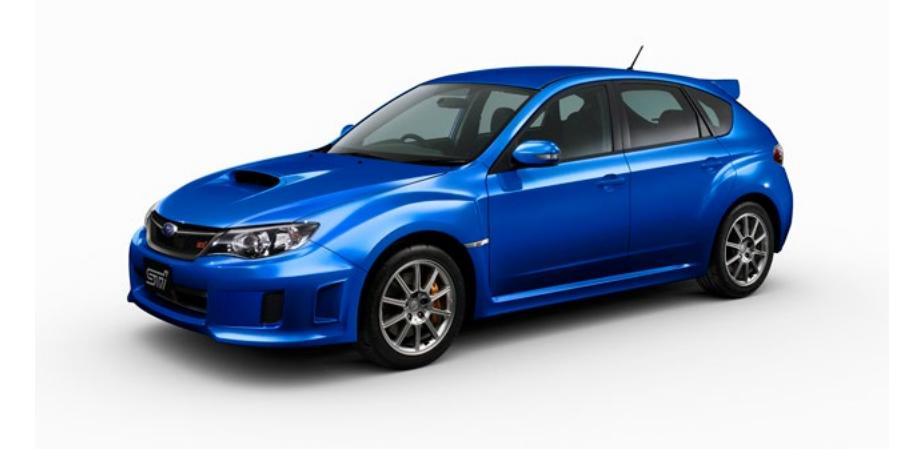
Subaru head gaskets

- Coolant condition is a good part of the problem with these
- There are updated head gaskets
- Subaru began using a different coolant in 2009
- The coolant is a phosphated hybrid organic acid (blue)
- When we do one of these we completely flush the system and upgrade to the new coolant
- If you use one of the green versions supply the customer with some of the coolant and make sure they do not mix.

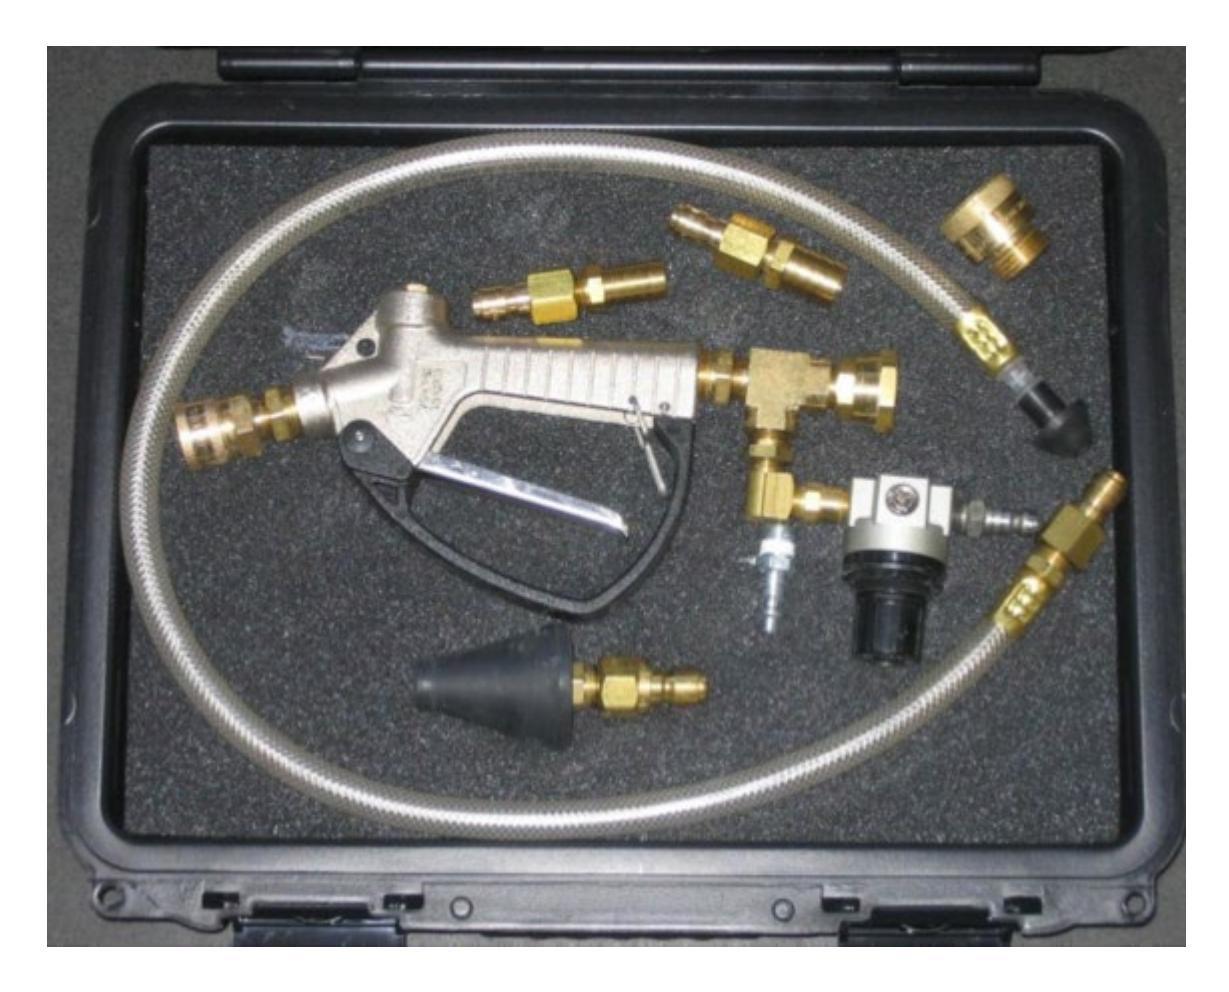
- Uses shop air and water
- Use to clean components individually
- Creates a scrubbing action by velocity
- Sold by Gates as Powerflush and by Hecat

- Flushing equipment should be updated to a pulsing component by component approach
- Gates and Hecat both have a tool that is recommended by OE's for backflushing heater cores. This tool works extremely well to flush the engine and radiator
- It is most effective to flush components backwards and then forwards
- Many vehicles will need the thermostat removed to effectively flush the engine
- If you capture the debris you wash out of the system customers will have a visual understanding of how this is a benefit
- Some water is left behind so you must blow out, add virgin antifreeze and use your refractometer to get the mix right.
