**XX Cutting & Coring
Page 1 of 1 - Overview**

**Ground Penetrating Radar Survey
Level 1 - Elevator Machine Room**

Terraprobe Geoscience Corp.

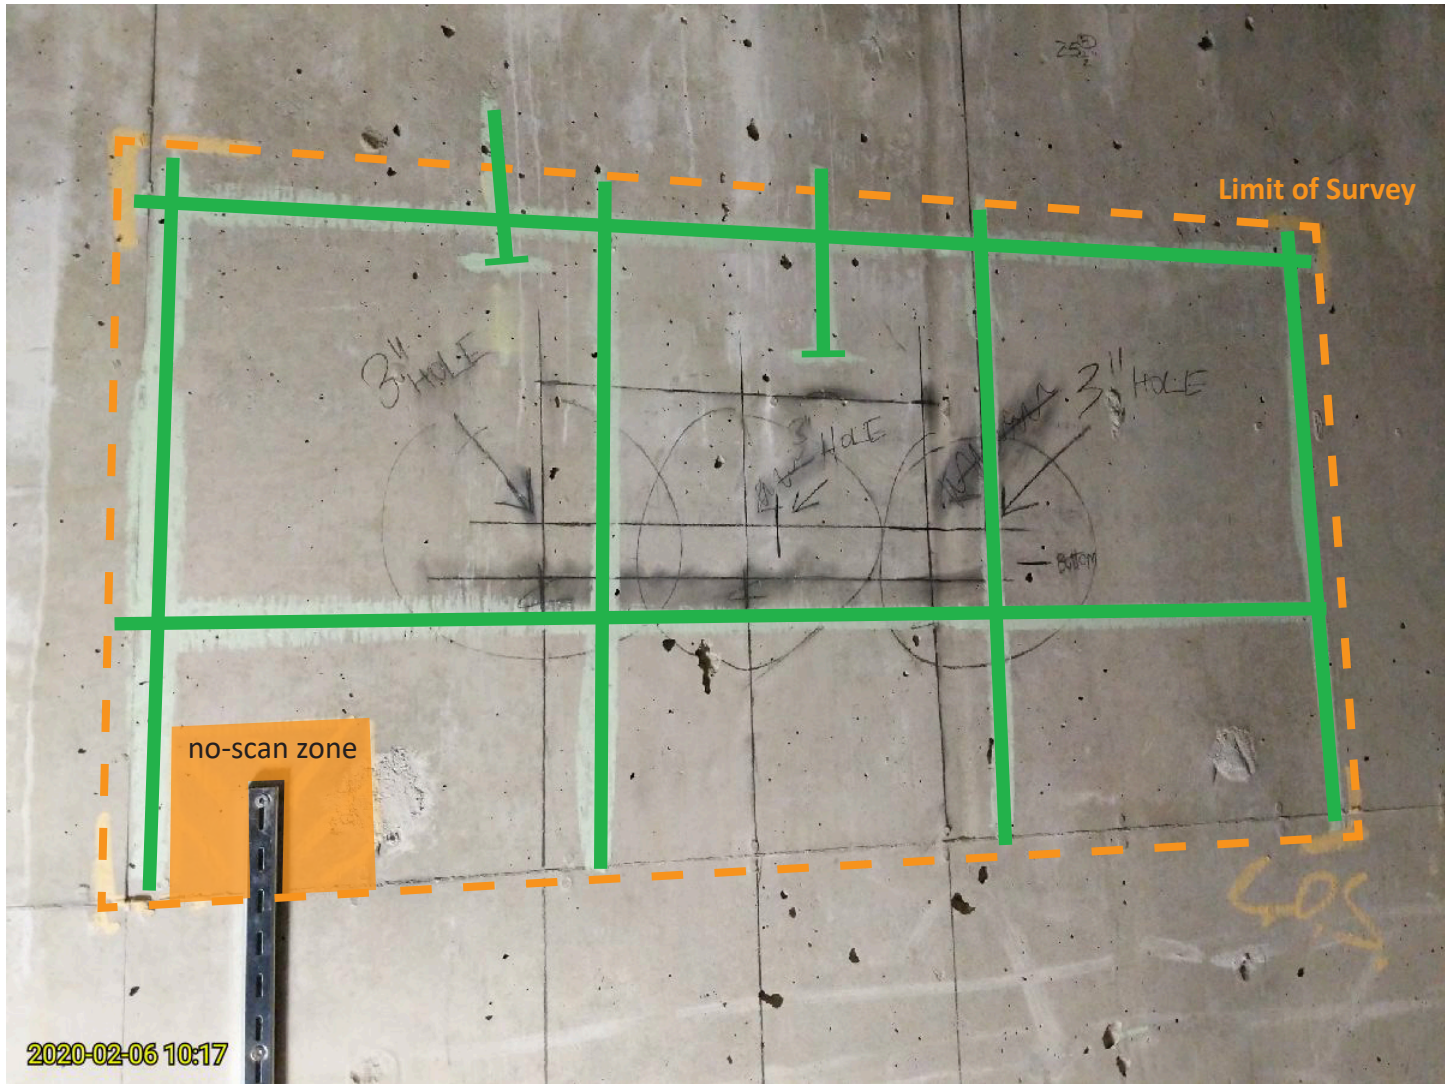
Photo of scanning results:

NOT TO SCALE
Wall thickness approx. 8"

Single layer reinforcing.

Recommendation: do not cut any targets. Keep 1" distance between edge of hole and markings.
